Manhole Inspection Summary

Manhole # S11M__011MH

Location Address: **3160 Leeds St**

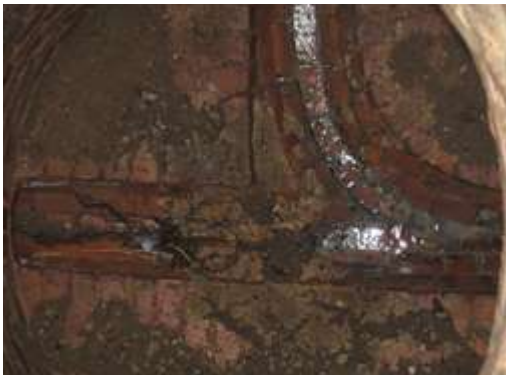
Defect 3

Condition: ☐ Sound ☐ Cracked ☐ Root Intrusion ☒ **Deteriorated** ☐ Leaks ☒ **Debris**

Debris in channel

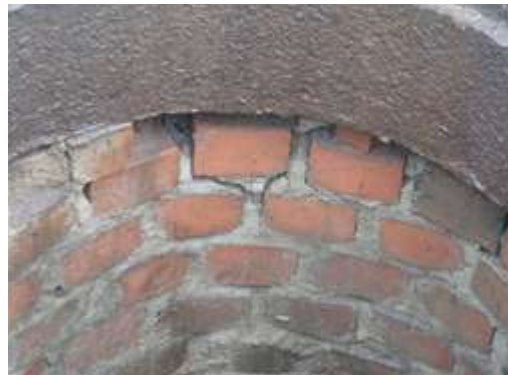
Defect 2

Condition: ☐ Sound ☐ Cracked ☐ Root Intrusion ☒ **Loose Brick** ☐ Deteriorated

chimney Loose bricks and mortar

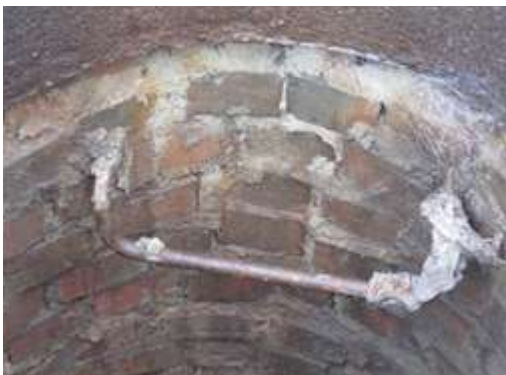
Defect 4

Frame Offset: **0** (in.) Condition: ☐ Sound ☐ Cracked ☒ **Leaks**

Steps Count: **5** Missing: **0** ☒ **Corroded**

corroded steps and frame leaks

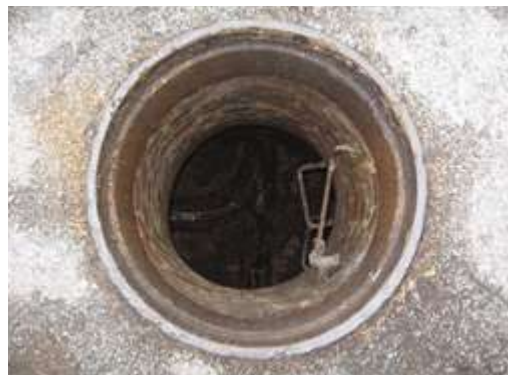
Defect 5

Frame leaks

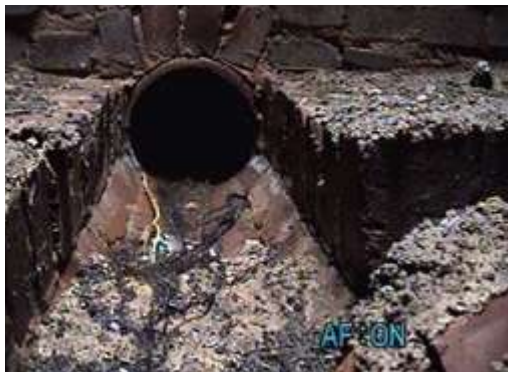
Defect 1

Debris in channel

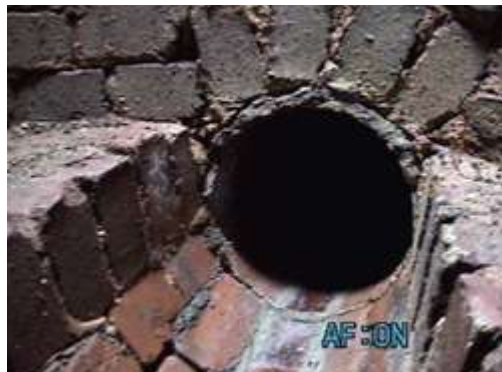
missing mortar in channel
